# Generator Insulation-Aging On-Line Monitoring Technique Based on Fiber Optic Detecting Technology

Peter Kung

## Abstract

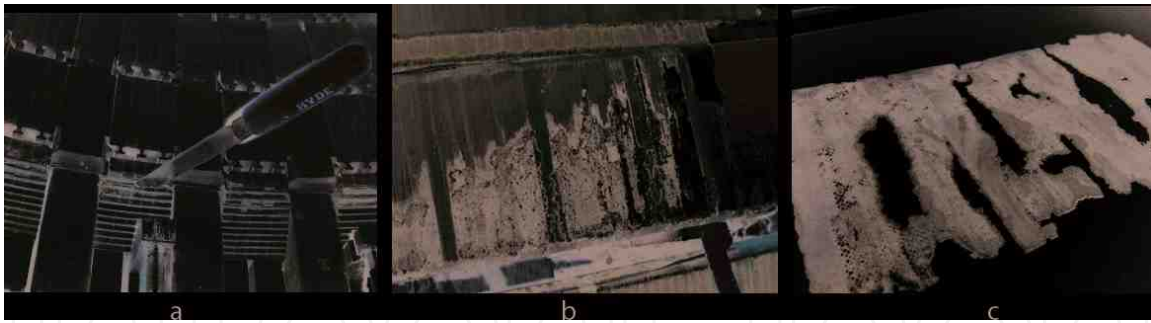
**Figure 1.** At the left, local loose core found using simple knife check. At the middle, defects start to appear as pinholes. At the right, partial discharge removes the conducting paint without affecting the underlying mica.

**Figure 1** (left) shows how vibration causes delamination in the core, allowing the varnish to wear out and then eddy currents to introduce hot-spots affecting the performance of the winding in the slot located close by. It becomes a downward spiral of mechanical degradation. Some of the cost reducing innovations that were previously introduced worked well in a base load operation. However, in a constant start-stop mode of operation, generators are susceptible to outage early in their life because they are air-cooled. The constant thermal cycling combined with the variable characteristics of the air contribute to early wear. They can suffer from a new failure mode called vibration sparking. This is the first time that this failure mechanism has been observed as failure in progress as shown in **Figure 1** (middle). They usually become uncovered upon a complete breakdown. A simple model that combines thermal aging and a mechanical vibration-assisted degradation process is introduced in the following sections.

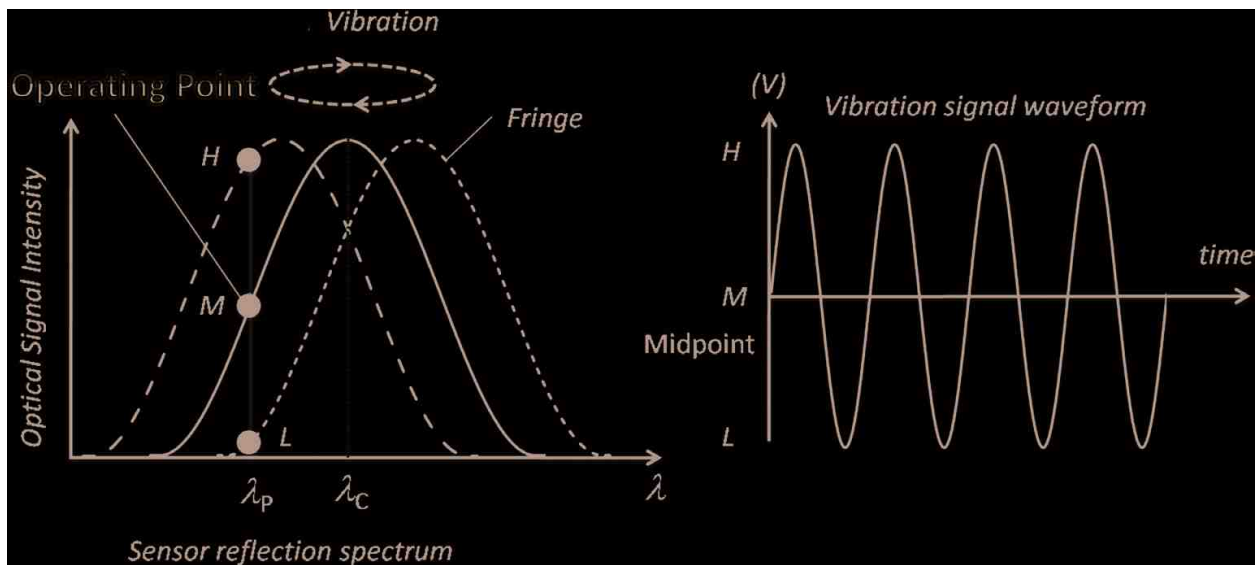
Figure 8. The principle of optical fiber sensing.

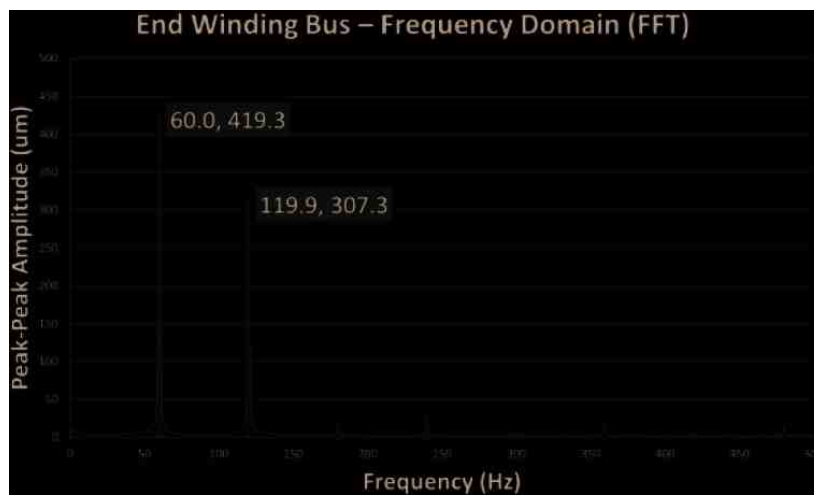
Figure 19. End winding bus frequency domain. Courtesy of QPS Photonics.

A third vibration sensor was mounted on the neutral end winding bus (see **Figure 17**). Once again, the vibration observed here is also consistent as depicted below in **Figure 19**.

Larger vibration amplitude is shown: 1xLF component measured 16.5-mil peak-to-peak and 2xLF measured 12.1-mil peak-to-peak. It seems that gas-fired generators vibrate much more than the coal-fired generators. Plant experts informed all participants of the field test that it may be related to the generator design where the bearing is coupled to the frame. Vibration was so strong in similar machines that cracks developed.

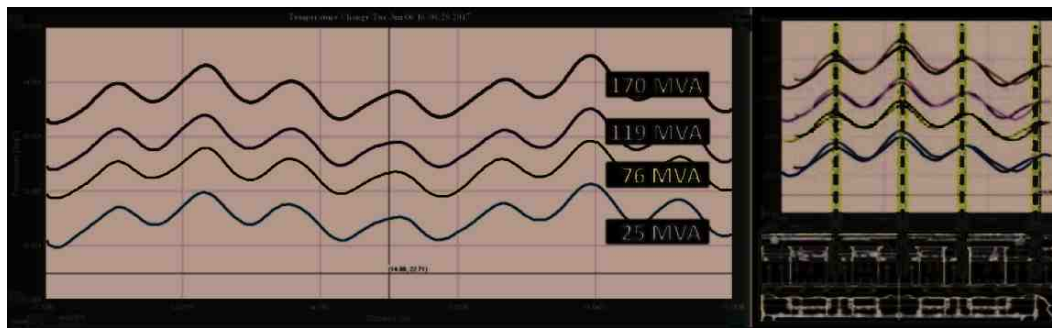
Figure 20. At left, temperature profiles at different loading intensities. At right, temperature profile line-ups with the air duct locations. Courtesy of Oz Optics, Ltd.

The temperature distribution inside the slot was measured by the Brillouin fiber optic loop sensor. The gathered data brought up a wave-like distribution as demonstrated in **Figure 20**

(left). The distribution is not flat; the cooling airflow did not form a perfect balance. The temperature extrema were less than 2°C apart, positively assuring the lack of hot spots.

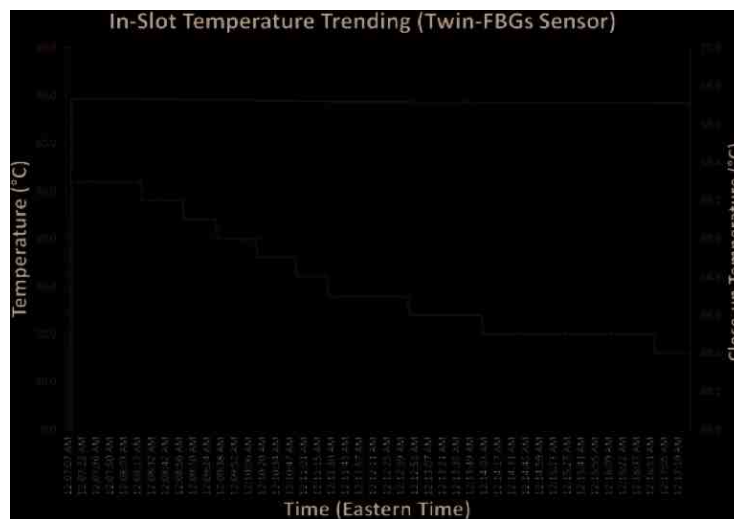
Figure 21. In-slot temperature measurement for 10 min. Courtesy of QPS Photonics.

**Figure 21** shows the temperature measurement of the in-slot sensor. The red plot indicates the coarse temperature reading of 70°C at a loading of 170 MVA. The blue line shows the fine temperature variation over a period of 10 min. The sensor was able to detect temperature changes down to 0.1°C.

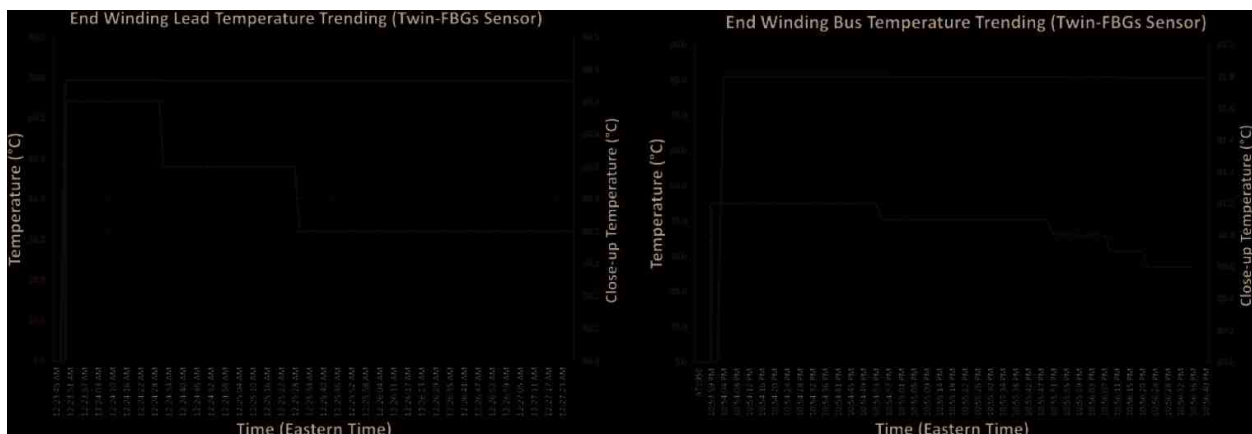
Figure 22. At left, end winding lead temperature measurement for about 5 min. At right, end winding bus temperature measurement for about 3 min. Courtesy of QPS Photonics.

The end winding lead of **Figure 22** (left) showed a temperature consistent with the slot as well as the end winding bus plotted in **Figure 22** (right). All of them read close to each other, there does not seem to be any problem.

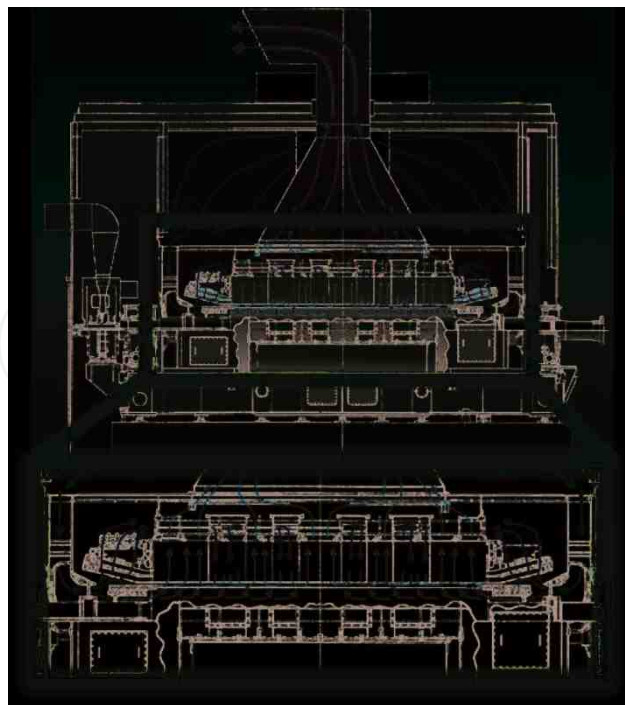
**Figure 23.** Siemens Westinghouse AeroPac I generator with emphasis on the radial airflow via colored arrows. Courtesy of Calpine Corporation.

The gas-fired generator involved in the field test was manufactured by Siemens [35–38]. Figure 23 shows a conceptual diagram of the cooling air radial flow. There are resistance

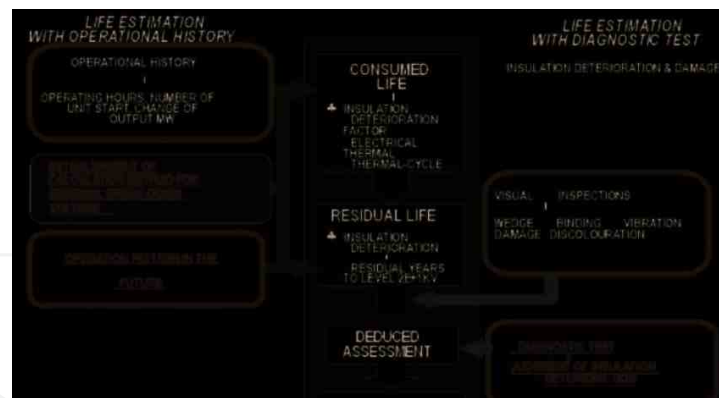
Figure 24. Damage model that allows residual life predictions.

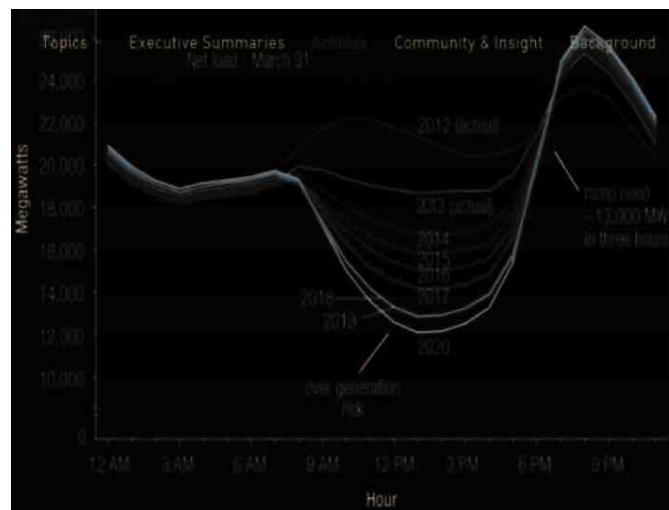
Figure 25. Graph showing gas generators must be turned on and off to adapt to the supply of the renewables.

It is now possible to simplify the problem into an intuitive model that does not involve complex mathematics [42–46]. The methodology is described below and can be used to analyze the measured data from these fiber optic sensors. It has been known that gas generators are frequently subjected to many daily start-stop events: the winds are usually stronger during the night and the sun shines more strongly late morning and afternoon. When these renewable energies become abundant, gas turbines must be turned off for the total power to not overload the power grid (see **Figure 25**).
