Neutron Irradiation Effects in 5xxx and 6xxx Series Aluminum Alloys: A Literature Review

Murthy Kolluri

A literature review on highly irradiated 5xxx and 6xxx series Al alloys is conducted to understand the expected changes in mechanical properties of high flux reactor (HFR) vessel material in relation with microstructural aspects beyond the current surveillance data to support the HFR Surveillance Program (SURP). It was found that the irradiation swelling in 5xxx series alloys is not a crucial degradation mechanism. Dislocation damage is expected to reach a saturation limit in both 5xxx and 6xxx series alloys at relatively low fast-fluence values ($<2 \times 10^{26}$ n/m²). The damage caused by precipitation of transmutation Si is found to be the dominant mechanism affecting the fracture toughness properties of irradiated 5xxx and 6xxx series Al alloys at high thermal fluence values. Tensile and fracture toughness data collected from the literature up to very high thermal fluences are analyzed in comparison with the available HFR surveillance data to predict the behavior of the HFR vessel material beyond current surveillance data. The observed changes in mechanical properties ar

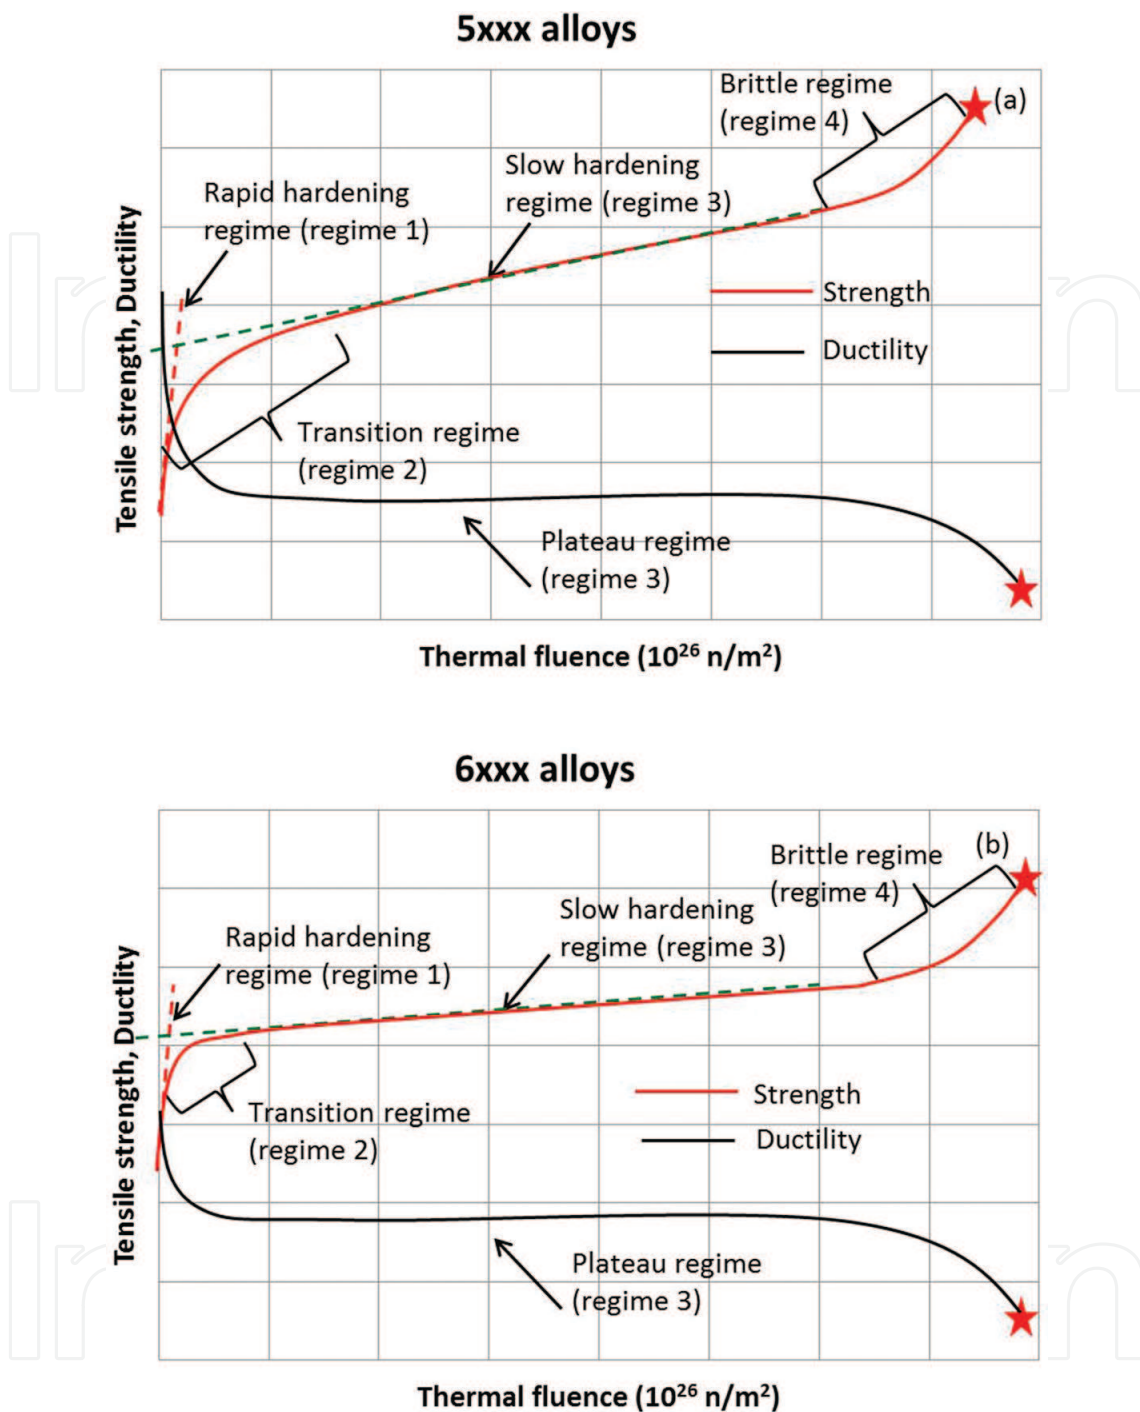
Figure 2. Schematic diagram showing various regimes in irradiation hardening behavior of (a) 5xxx and (b) 6xxx series Al alloys.

The differences in irradiation hardening trends in all four regimes of 5xxx and 6xxx series alloys are depicted schematically in **Figure 2**. Both 5052-O and 5154-O alloys show similar irradiation hardening and embrittlement behavior (**Figure 1**) due to similar alloy microstructure and irradiation conditions. The unirradiated strength values of 5052-O and 5154-O alloys are lower, and ductility is higher than 6061-T6 alloy (**Figure 1**) due to the absence of Mg_2Si precipitates before irradiation. In the rapid hardening regime, the magnitude of irradiation hardening and embrittlement in 5xxx series alloys is observed to be much higher than 6xxx series, because both dislocation hardening (due to displacement damage) and precipitation hardening (due to the formation of Mg_2Si precipitates from transmutation Si) occur simultaneously in 5xxx alloys (see Section 3.1).

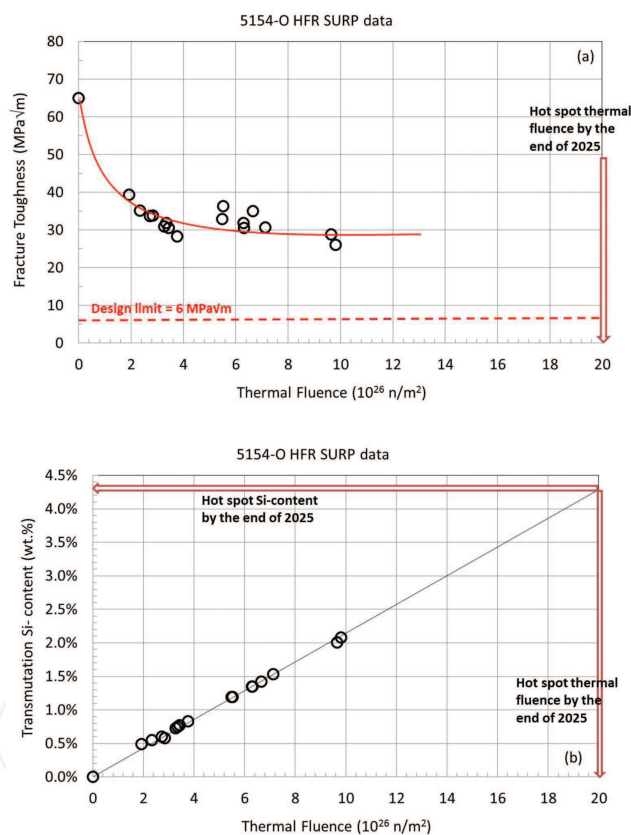
Figure 3. (a) HFR SURP fracture toughness data as a function of thermal neutron fluence. (b) Transmutation Si values as a function of neutron thermal fluence of fracture toughness samples tested in HFR SURP program. Note that the projected hotspot thermal fluence and Si content are based on the assumption that the irradiation conditions at the HFR hotspot are kept unchanged as they are in 2015.

No additional data on fracture toughness properties of 5xxx Al alloys was found in the literature except the data from 5154-O alloy from HFR SURP [13]. The fracture toughness properties of the HFR surveillance specimens are periodically measured to assess and predict the hotspot behavior of HFR vessel in comparison with the vessel's fracture toughness design limit of $6 \text{ (MPa)}\cdot\text{m}^{1/2}$ [22]. Fracture toughness properties of surveillance specimens from the current HFR vessel tested until 2010 are plotted as a function of thermal neutron fluence in **Figure 3 (a)**. The thermal neutron fluence is taken as an indicator for the measure of irradiation damage in HFR vessel material, because thermal neutrons are the major cause of damage by producing Si through transmutation, as explained in the previous sections. **Figure 3 (b)** shows the relation between the thermal fluence and transmutation Si in fracture toughness specimens tested in SURP.

In the rapid hardening regime (regime 1), the fracture toughness value drops rapidly in line with the observed hardening and ductility behavior of 5xxx alloys (**Figure 3** vs. **Figure 1 (c)**).

After that, the fracture toughness of 5154-O reaches a plateau at a thermal fluence of $\sim 4 \times 10^{26}$ n/m² after which no further increase in dislocation and precipitate density is expected (**Figure 3**). In fact, a small decrease in particle density may occur later in this regime due to particle coalescence during their growth. The opposite effects of a small decrease in particle density and a slow hardening due to precipitate growth on embrittlement could be compensating each other leading to a plateau in the fracture toughness behavior (similar to ductility) in regime 3. The behavior of 5154-O alloy is expected to be similar to 6xxx series alloys in this regime at similar irradiation conditions. This is because within this regime the irradiation hardening in both alloy types occurs primarily due to the growth of existing precipitates by newly produced transmutation Si. A close agreement between the fracture toughness data of 6061-T6 alloy irradiated in HFIR at <373K and HFR SURP data in the plateau regime (see **Figure 4**) confirms this theory.

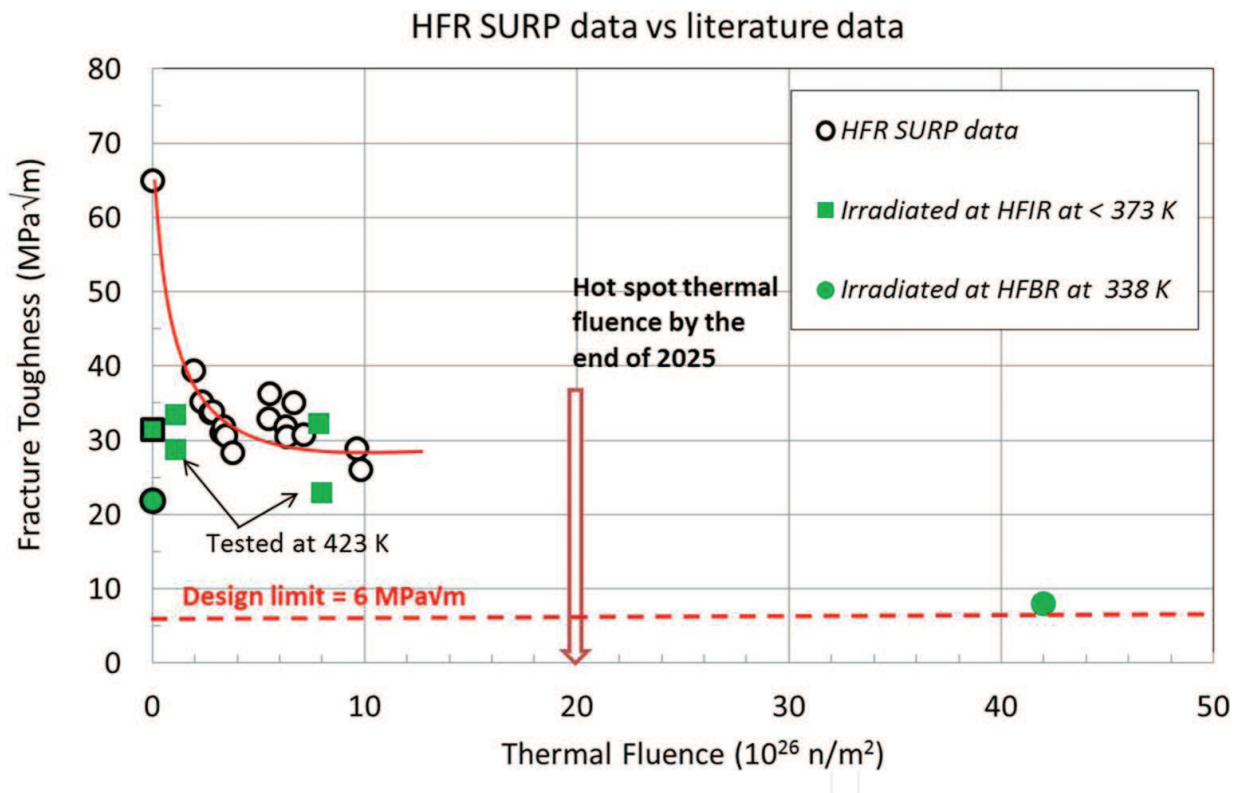
Figure 4. HFR SURP fracture toughness data in comparison with literature data [5,10].

Only limited data was published on fracture toughness properties of irradiated Al alloys [5, 8, 10]. The most relevant data for the HFR (irradiation temperatures $< 373 \text{ K}$) is plotted in

Figure 4 in comparison with HFR SURP data. Data from 6061-T6 alloy irradiated at < 373 K in the High Flux Isotope Reactor (HFIR) in Oak Ridge National Laboratory, USA matches quite well with the HFR SURP data. As it can be seen from **Figure 4**, there is one high fluence data point published by Weeks et al. [5] beyond the current surveillance data of the HFR vessel. This data is from the CRDF A-2 tubes of the HFBR in Brookhaven National Laboratory, USA, produced from 6061-T6 alloy, irradiated at 338 K up to a thermal fluence of 42×10^{26} n/m². The corresponding fast fluence of this data point is 2×10^{26} n/m², which gives a high TFR of 21, compared to the HFR hotspot TFR value of maximum 1.4. The total measured Si at this fluence was found to be ~8 wt.%, including 0.6% of initial Si content. The reported thermal fluence and Si content of this data point are approximately two times the estimated thermal fluence ($\sim 20 \times 10^{26}$ n/m²) and Si (~4.3 %) content of the HFR hotspot by the end of 2025. Note that this data is from the same material and at the same irradiation conditions for which the tensile data at very high thermal fluences ($\sim 42 \times 10^{26}$ n/m²) is also available (see **Figure 1**).

This is because the hardening-induced embrittlement causes the decrease in both ductility and fracture toughness properties. In this regime, the magnitude of the drop in 5xxx alloys is high compared to 6xxx alloys, because both dislocation damage and precipitation damage mechanisms are active in 5xxx alloys, whereas only dislocation damage dominates in 6xxx alloys. This explains the sharp drop observed in fracture toughness of 5154-O alloy at the onset of irradiation compared to a shallow decrease in fracture toughness properties of 6061-T6 alloy in this regime (see **Figure 4**).

CRDF A-2 tubes of HFBR produced from 6061-T6 alloy have shown a fracture toughness value of ~ 8 (MPa) \cdot m^{1/2} after irradiation to a much higher thermal neutron fluence of $\sim 42 \times 10^{26}$ n/m² at 338 K (see **Figure 4**). The decrease in fracture toughness from an unirradiated value of 21.75 (MPa) \cdot m^{1/2} for this alloy is primarily attributed to the following: (i) formation of very fine (~ 8 nm) Si-rich precipitates in the grains due to high TFR of 21 (as explained in Section 4.4) and (ii) large silicon flakes occupying about one-fifth of the grain boundary area at this high transmutation-produced Si content of 8 wt.% [5]. Fracture surface of this alloy revealed substantial intergranular separation with some residual ductility indicating that the contribution of grain boundary fracture mechanisms is increased at such high fluence values to enter into the brittle regime (regime 4).

However, the fast flux can be destructive when a freshly formed nucleus is hit by fast neutron collision. That means, at equal thermal fluence values, Si precipitation hardening is more effective at higher TFR. This leads to finer precipitate distribution, causing higher irradiation hardening, lower ductility, and eventually lower fracture toughness values at higher TFR. Indeed, the higher hardening rate observed in 6061-T6 alloy from CRDF A-2 tubes of HFBR irradiated at TFR of 21 compared to the similar 6061-T6 alloy irradiated in HFIR at TFR of 1.7 explains this behavior (**Figure 1 (b)**). Consequently, the high fluence data point from CRDF A-2 of HFBR at TFR = 21 ($\gg 0.8\text{--}1.4$ for HFR hotspot), shown in **Figure 4**, is likely to give a conservative estimation of the fracture toughness value under HFR conditions.
