Early Complications after Pacemaker Implantations

Kabayadondo Maidei Gugu and de Meester Antoine
*Jolimont Hospital
Belgium*

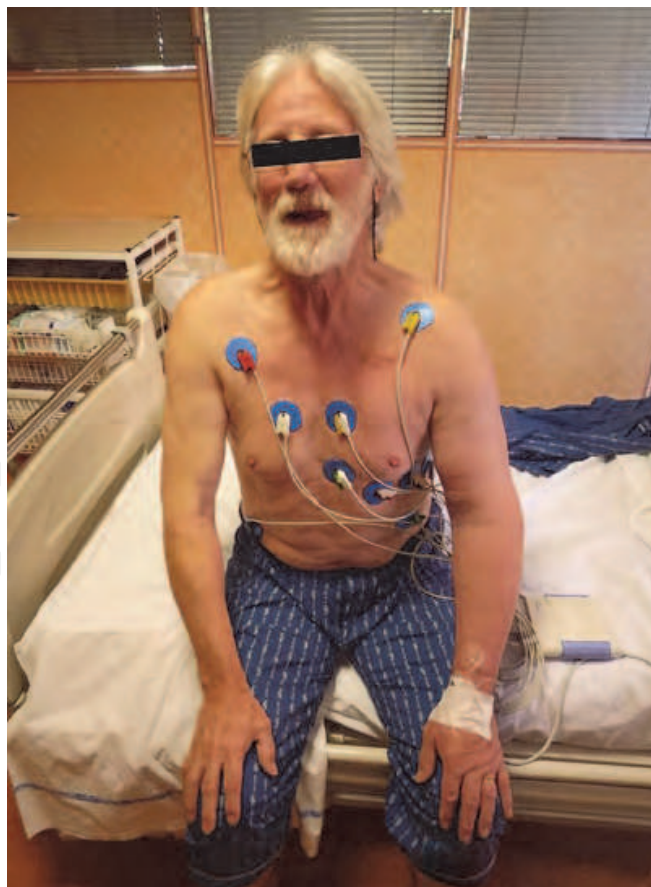
A 73 year old male has a defibrillator with resynchronisation implanted for ischemic cardiomyopathy after an anterior infarction left him with a left ventricular ejection fraction of 25%. He had presented an episode of ventricular tachycardia with syncope. Implantation of the device was by the subclavian route. There were no immediate post-operative complications and good parameters were recorded for all three leads. Three weeks later, the patient complains of discomfort in the left arm, followed by oedema of the whole arm, forearm and hand (Figure 11); ultrasound and vascular tomodensitometry confirmed complete thrombosis of the left subclavian vein, of the axillary vein, leading up until the convergence of the jugular vein. Anticoagulation therapy was commenced and evolution was slow but favourable in the following weeks.

Fig. 11. Oedema of the left arm, forearm and hand caused by massive thrombosis of the subclavian vein after defibrillator with Cardiac Resynchronisation Therapy (CRT-D).

Comments: Subclavian vein thrombosis is not uncommon. It can occur in about 30% of cases, but usually remains asymptomatic due to the rapid development of collateral circulation (Oginosawa et al., 2002). Less than 5% of patients are symptomatic, presenting mainly with pain or oedema of the arm closest to the implantation site. Risk is higher in cases where three leads are implanted (Cardiac Resynchronisation Therapy (CRT), when the patient is under hormonal therapy, when personal history of thrombo-embolic event is present, with temporary ipsilatérale transvenous lead, during upgrade of a simple pacemaker to a pacemaker with resynchronisation, dual coil leads, and when the ejection fraction is less than or equal to 40% (Da Costa et al., 2003 ; Rozmus et al., 2005). The risk of thrombosis does not differ for pacemakers and implantable cardioverter-defibrillators. Preventive measures may be necessary (platelet aggregation inhibiting drugs or anticoagulation therapy).

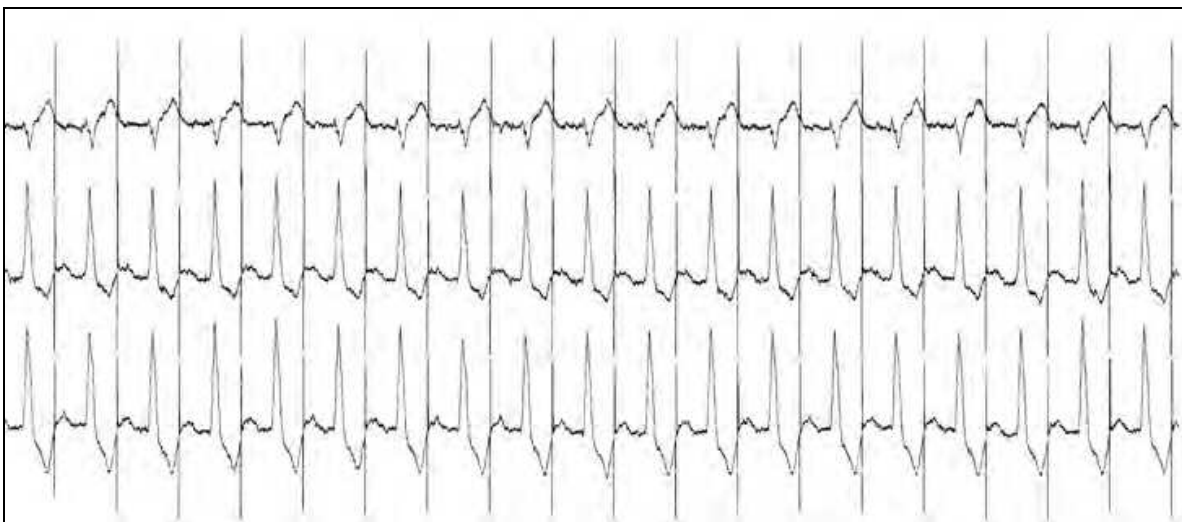
A 75 year old male is admitted for repeated fainting caused by major sinus dysfunction as shown by a 24 hour Holter monitor which revealed pauses of up to 8 seconds and paroxysmic atrial fibrillation. Medical history was negative and patient was on no current treatment. EKG at rest showed a sinus rhythm with a frequency of 68 bpm and normal repolarisation. A physiological pacemaker is implanted in the operating room. After the intervention, the patient feels palpitations and an EKG recording shows probable pacemaker-mediated tachycardia (Figure 12). Programming control shows a P-R sensing of 15.8 mV and 1.2 mV respectively, and threshold values for stimulation both inferior to 0.5 volts for 0.4 msec; a connection error is confirmed during threshold verification. Programming in AAI mode would result in VVI pacing, and programming in VVI mode would result in AAI pacing. Re-intervention allowed the correction of this connection error.

Fig. 12. Tachycardia due to an error in the connection of the atrial and ventricular leads. We note the same QRS configuration as with VVI pacing from the apex.

Comments: Atrial and ventricular lead connection errors are rare at implantation, but have already been documented (Barold et al, 2010). Programming verification allows rapid detection of the switch (“green wire on the green button and red wire on the red button”). A control of the programming of a stimulator is mandatory before patient discharge. It

allows detection and correction of such an error, as well as early detection of a lead displacement. Different types of tachycardia are to be excluded:

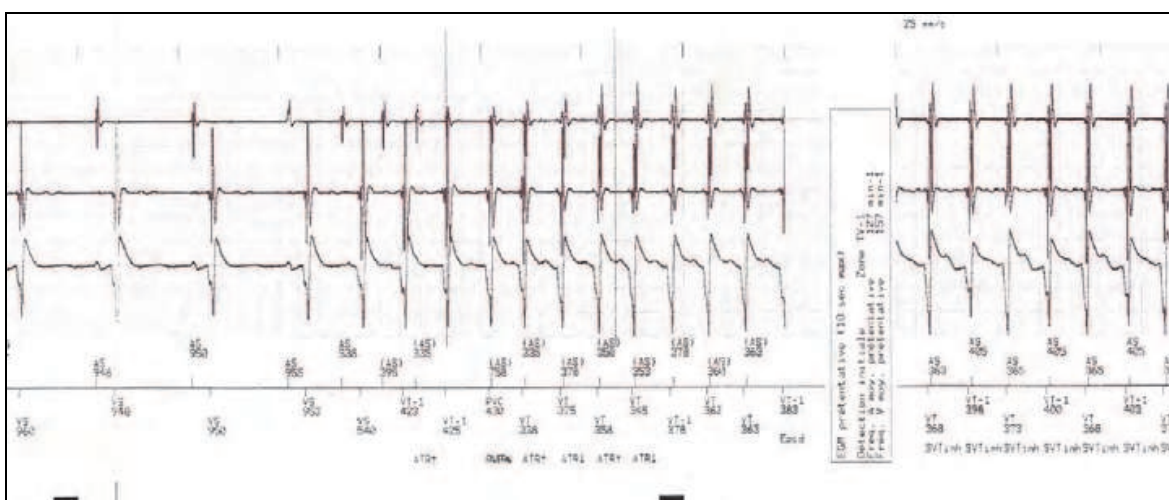
- figure 13 shows the initiation of the common type (slow-fast) of atrioventricular nodal reentrant tachycardia ; this is a typical example where the arrhythmia is triggered by an atrial extrasystole which blocks the rapid pathway of the atrioventricular node and allows flow through the slow pathway and thus initiation of the supraventricular tachycardia circuit

Fig. 13. Baseline rhythm strip showing atrial, ventricular and shock intracardiac electrogram leads, and marker atrial and ventricular channels. This is an example of initiation of common atrioventricular node reentrant tachycardia; see text.

- radiofrequency ablation is the treatment of choice.
- Other reentrant tachycardia includes
 - atrial flutter
 - orthodromic circus movement tachycardia using an accessory pathway in the retrograde direction and the AV node in the anterograde direction (concealed or not, in the Wolff-Parkinson-White syndrome)
