Influence of Immersion Lithography on Wafer Edge Defectivity

K. Jami, I. Pollentier, S. Vedula and G. Blumenstock

Source: Lithography, Book edited by: Michael Wang,
ISBN 978-953-307-064-3, pp. 656, February 2010, INTECH, Croatia, downloaded from SCIYO.COM

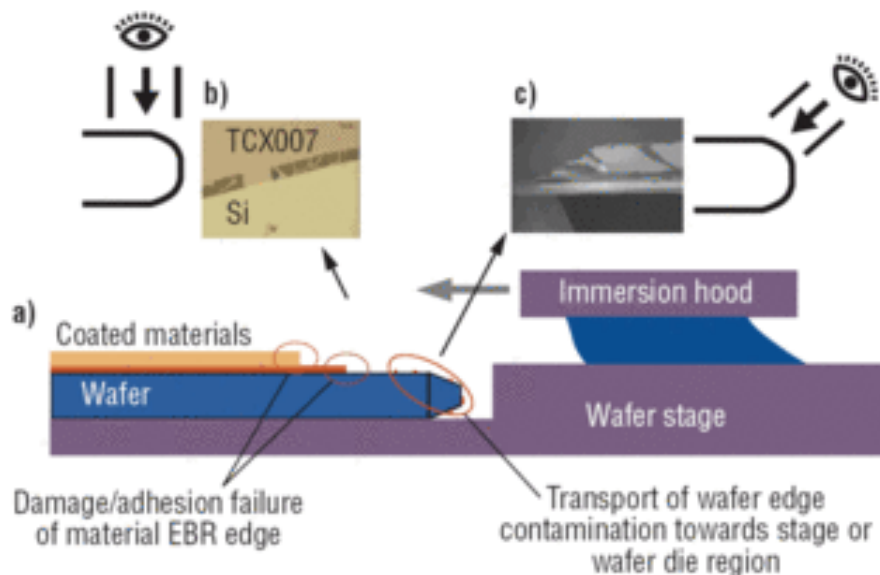
Fig. 1. a) Schematic representation of possible defect issues with immersion lithography; b) example of damaged photoresist material inspected with top-down optical microscope; and c) example of damaged residues at the wafer edge, inspected by tilted SEM (45°).

Immersion lithography [1-4] has changed the way we view defectivity issues at the wafer edge significantly. During the immersion exposure sequence, the wafer edge is in contact with the water from the immersion hood (IH), introducing additional concerns beyond direct contact of resist with the scanner. First, when the IH is scanning in the EBR region, its movement can damage material edges (Fig. 1a). IMEC's program on immersion lithography found that, for example, photoresist material can partially peel off during the IH pass (Fig. 1b).

A second concern involves the cleanliness of the wafer edge outside the EBR edges. The IH pass wets not only the near-edge top surface, but also the curved wafer edge and even part of the bottom surface. Defects can be released from this area and re-deposited either on the wafer or on the wafer stage. In the first case, there will be a direct impact on the wafer defectivity. In the latter case, defects present on the wafer stage can be transported onto wafers in subsequent wafer processing. IMEC's program on immersion lithography found that resist residues left on the curved wafer part by an incomplete EBR step can be damaged by the IH pass, releasing fragments into the system (Fig. 1c).

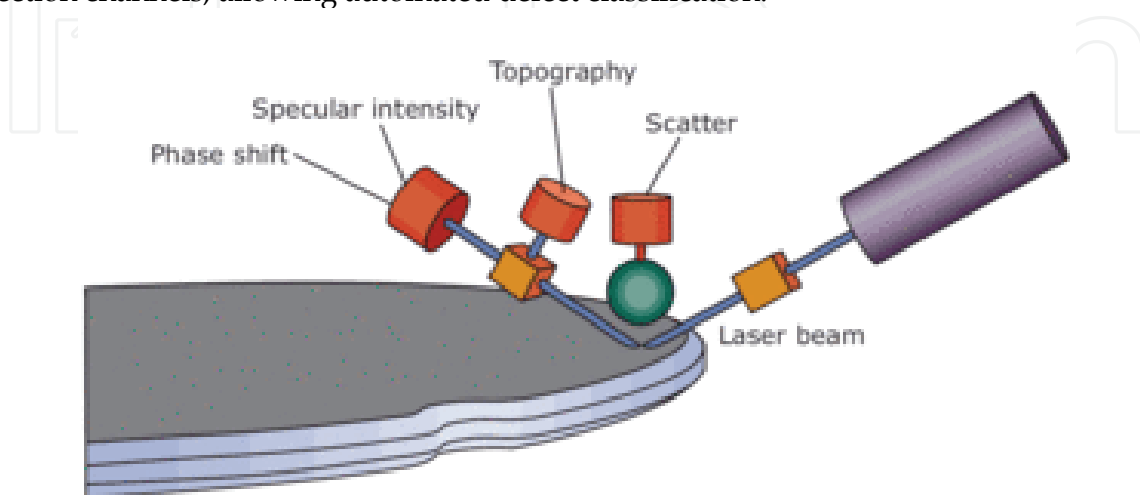
The new measurement system for wafer edge defect inspection (Fig. 2) is based on a laser source directed to the wafer edge surface. Three detectors simultaneously collect the scattered light, the specular or reflected light and the phase difference between different polarization states. As the laser scans the wafer edge surface, each signal can be converted into an image. Each type of defect produces a specific combination of signals from the three detection channels, allowing automated defect classification.

Fig. 2. Schematic representation of the VisEdge measurement principle.

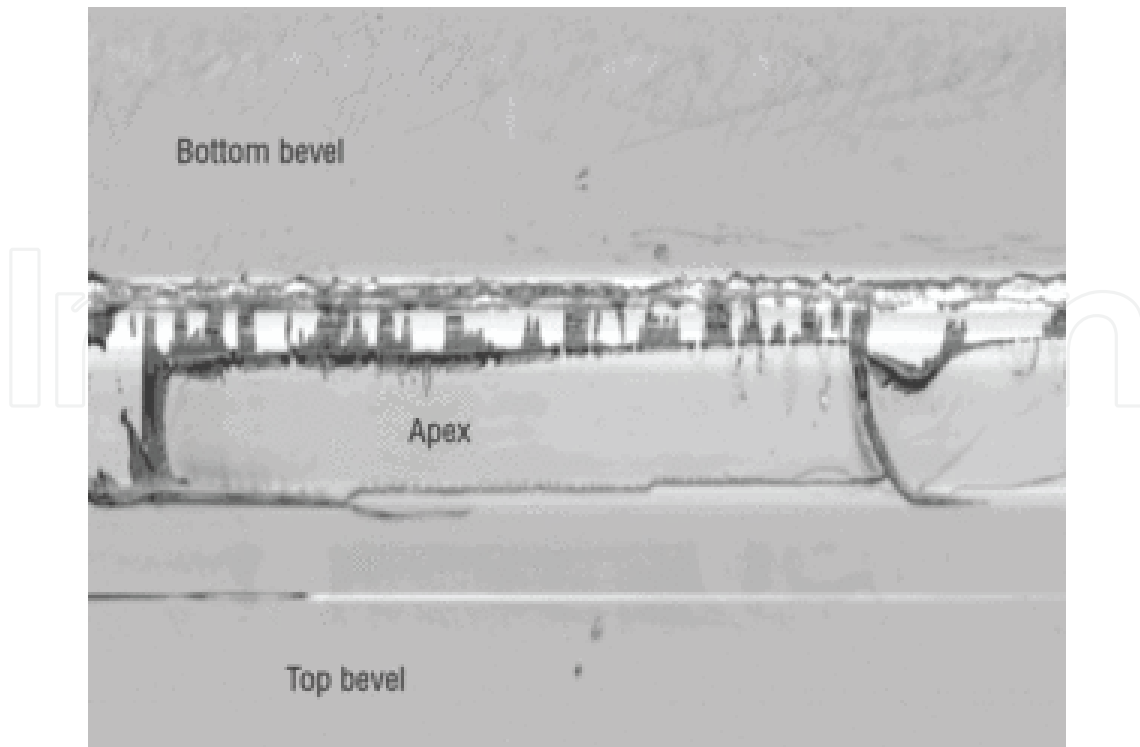
Fig. 3. Example of a specular image using the new technology showing part of the bevel/apex region. This kind of representation is valuable for the evaluation of wafer edge quality.

For wafer edge cleanliness, a high-resolution view of the wafer edge is typically more useful. Here, the images view only a few millimeter of the edge. Figure 3 uses this representation to show resist flakes observed along the apex-bevel regions in the specular channel.

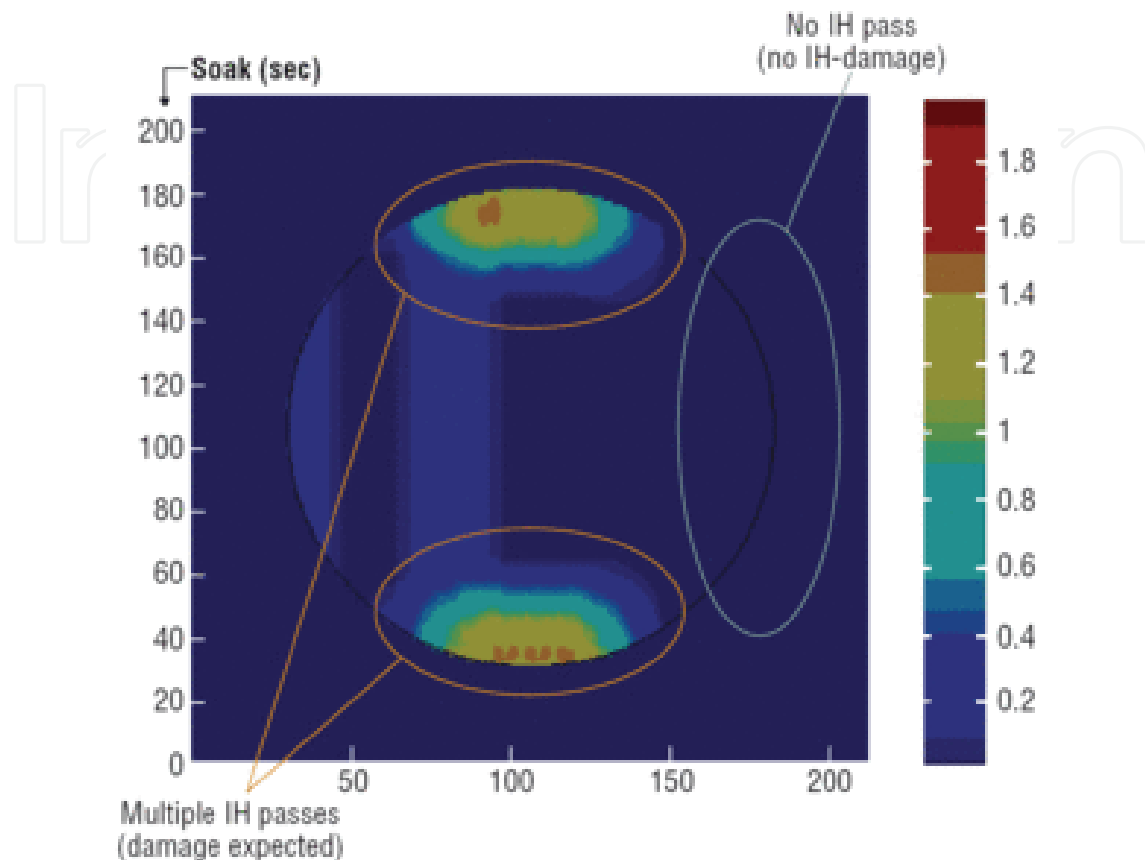
Fig. 4. IH exposure sequence for edge flake characterization.

We experimented with three resists with different chemistries (**Fig. 4**). Sensitivity to edge damage was expected to vary across the three resist types. A dedicated exposure job spatially separated the areas where flakes are expected and where they are not expected. One section, consisting of two rows of 11 fields, was exposed close to the wafer edge at the opposite side of the notch. A similar area of two rows of 11 fields was exposed in the region of the notch. During the exposure of these 2×11 sections at both locations near the wafer

edge (Region II), the IH makes continuous up- and down-scans over the wafer edge area, increasing the probability of defect generation. The exposure job was also designed so that on another part of the wafer (Region I, on the right hand side), the immersion hood did not pass over the wafer edge. In Region I, no flake-like defects were expected.

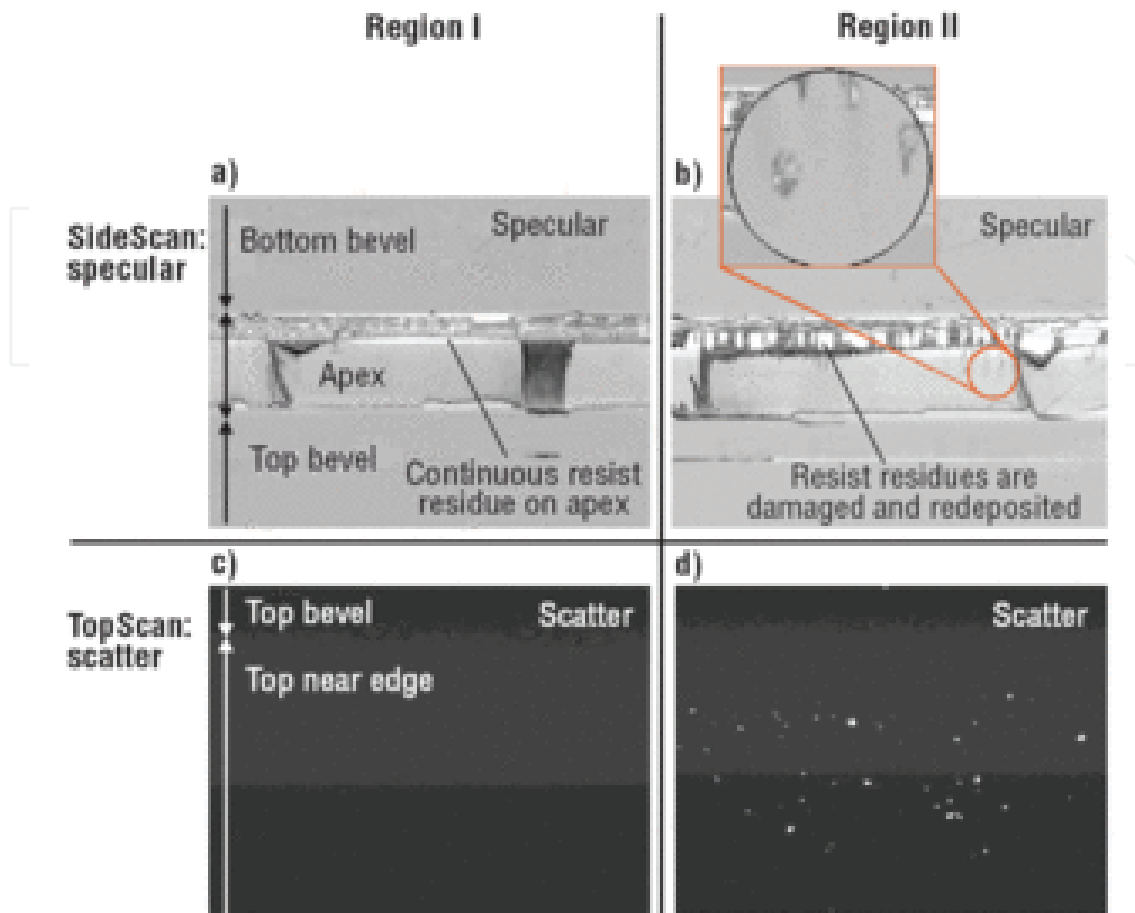
Fig. 5. Specular and scatter images from Region I (a and c) and Region II (b and d) of a test wafer. IH damage is more likely in Region II.

We compared the SideScan images of areas where the IH did and did not pass. Figure 5a is a typical SideScan specular image for region I (where the IH did not pass). Differences in thick and thin resist residues are visible, but no fragments of the resist residues are evident. In contrast, in Fig. 5b, taken from Region II, indicated that parts from the thick residue at the bottom of the apex were released. The close-up in the image indicates that some of these edge flakes were re-deposited on the apex closer to the top.

To determine whether any of these edge flakes end up on the top region (where edge die can be damaged), we analyzed the TopScan image of the corresponding areas of Fig. 5a and 5b using the scatter channel, as shown in Figs. 5c and 5d. In Region II, a lot of particles were detected, while in Region I, no particles were observed in the images. This observation was encouraging for further ADC work.

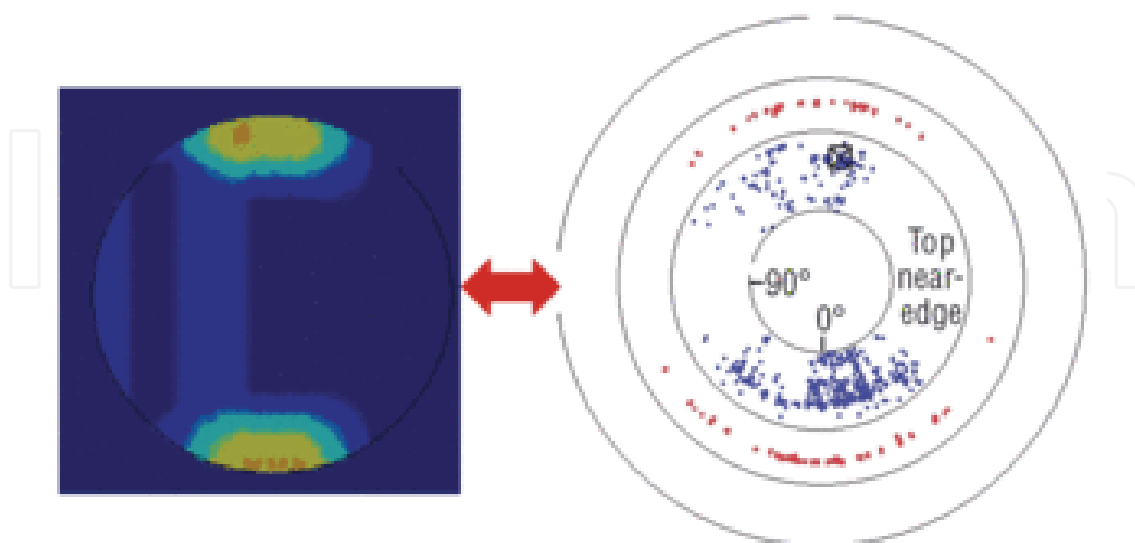
Fig. 6. Immersion characterization (quantification of edge flakes at wafer edge); the flakes on the apex and top near edge can be quantified by composite analysis of SideScan and TopScan signals.

channel of the SideScan image. For re-deposited defects in the top near-edge region, a combination of signals in the specular and scatter channels gave more accurate classification. Once all the measurement parameters for both areas are fixed, they can be combined in a single measurement sequence that provides defect classification and mapping for all the wafer edge areas of interest. (Fig. 6).

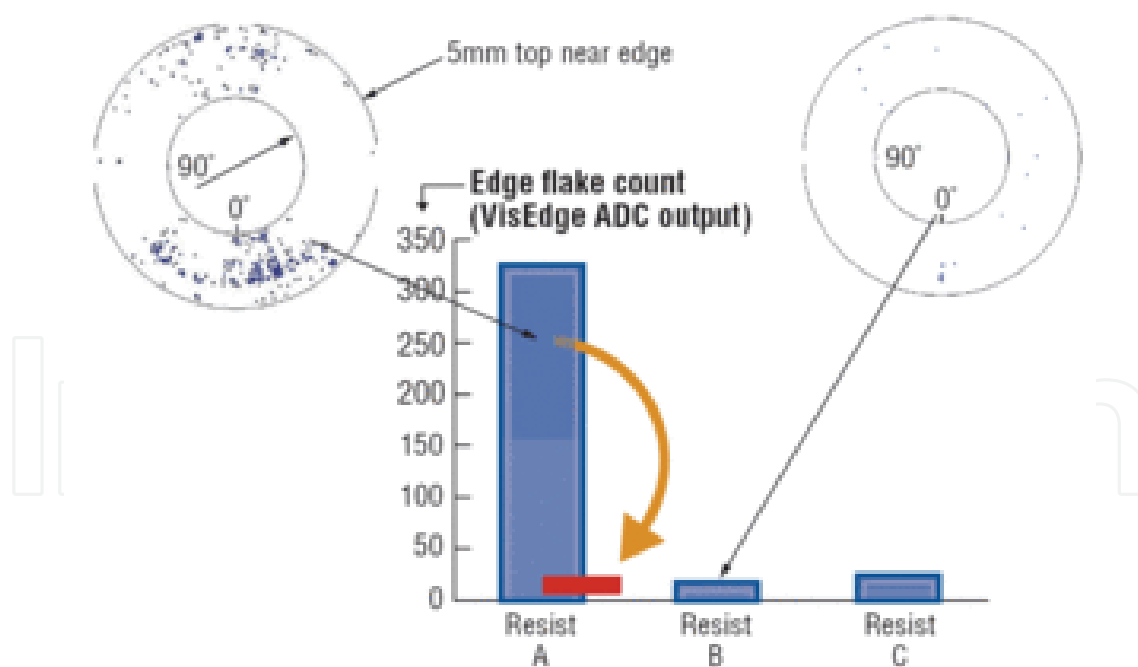
Fig. 7. Edge flake defects as a function of resist chemistry and EBR recipe.

When the same immersion exposure was used, significantly fewer edge flakes were detected in the near top region for Resist B and C than for Resist A (Fig. 7). Moreover, the residual defects were less confined to the exposure zone, so some of these defects might be caused by coating and wafer handling. In the TopScan images, no clear sign of damage was seen. Clearly the choice of resist chemistry can be important to prevent these kinds of defects.

As indicated earlier, resist residues can be optimized by changing the EBR recipe on the coat track. Resist A showed several hundred defect flakes with the regular (short) EBR sequence. After optimization, this resist achieved defect values similar to the background values obtained with the non-flaking resists B and C.
